TECHNICAL BULLETIN

LM501-001v4

SECTION: 501-02 (Body System - 76)

Range Rover (LM) - Wind Noise Diagnostics Aid

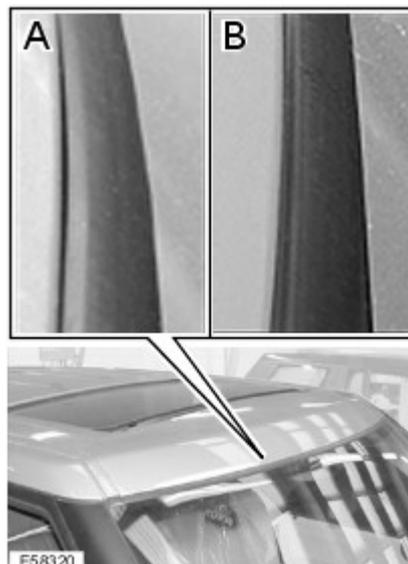
A high-pitched hiss from the windshield 38 - 50mph (60-80km/h).

Caused by a gap between the windshield top finisher and the edge of the roof (refer to 'A' in illustration of step [1](#)).

Using a nylon block and rubber mallet, gently move the windshield top finisher upwards to close the gap to the roof until a touch condition is achieved along its entire length ('B' in illustration).

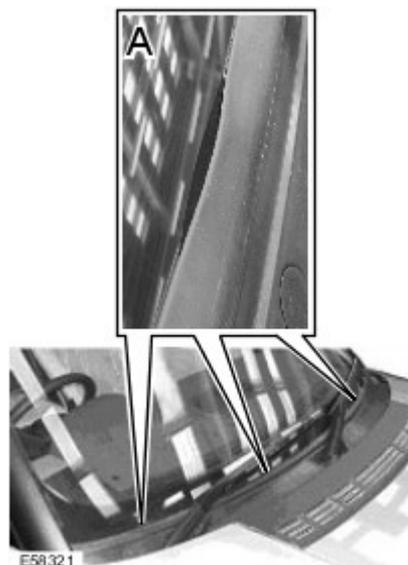
Buzzing from the windshield around 70mph (112km/h).

Caused by a gap between the windshield lower finisher and the windshield (refer to 'A' in illustration of step [1](#)).

1. Lift wipers away from the windshield for access.

2. Clean the contact point between the plenum seal and the windshield along the entire length of the plenum seal.
3. Apply sealant between the plenum seal and the windshield to ensure the entire length of the plenum seal and any gap(s) are completely sealed.
4. Remove excess sealant.
5. Lower wiper blades into position.

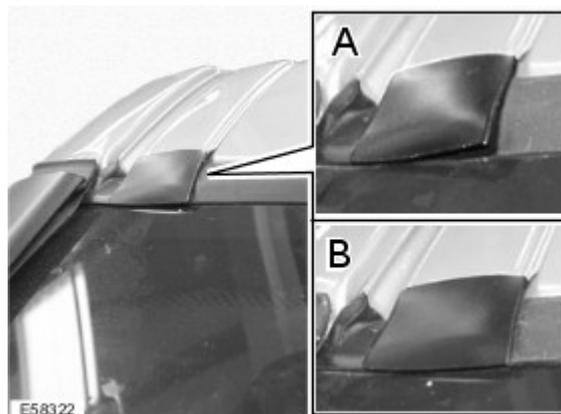
A noise from the top corners of the windshield.

Caused by a gap between the windshield and the roof molding (refer to 'A' in illustration of step [1](#)).

1. Remove the roof molding and refit, ensuring correct fore/aft position to achieve a good flush fit.

2. The rear end of the roof molding should be lined up with the rear edge of the roof. For additional information, refer to Range Rover (LM) Workshop Manual Section Exterior fittings, Roof moulding (76.43.68).

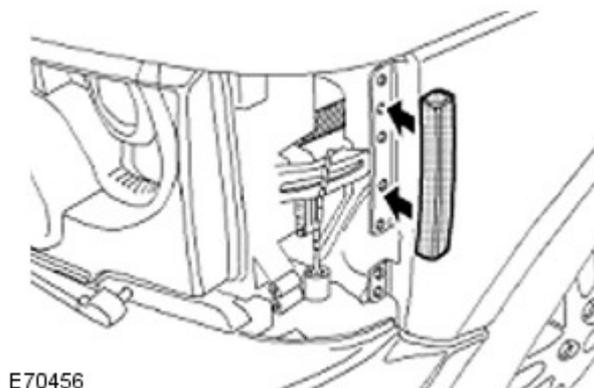
A high-pitched whistle noise from the front of the vehicle at speeds in excess of 81mph (130km/h).

Caused by a gap between the direction indicator lamp and the wing.

1. Remove the left-hand and right-hand front indicator lamp assembly For additional information, refer to Range Rover (LM) Workshop Manual Section 86.2 - Lighting , Lamp assembly side and indicator (86.40.29).
2. Clean the fender where the adhesive rubber strip is to be installed (see illustration E70456).

3. Remove protective backing from the adhesive rubber strip and secure to the fender (see illustration E70456).
4. Install the left-hand and right-hand front indicator lamp assembly For additional information, refer to Range Rover (LM) Workshop Manual Section 86.2 - Lighting , Lamp assembly side and indicator (86.40.29).

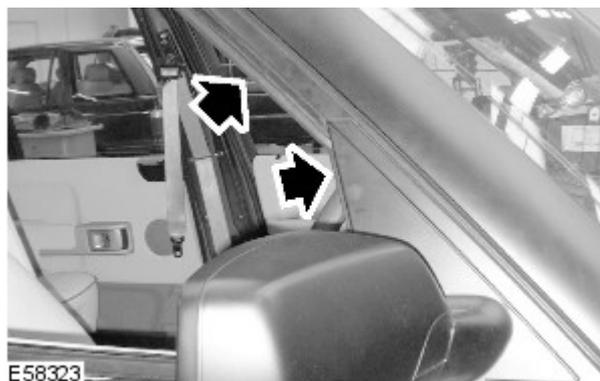
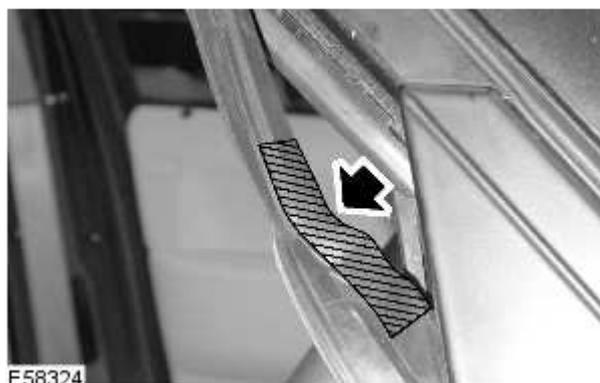
A hiss or leakage noise at speeds of 40mph (64km/h) upwards from around the A-pillar and door mirror area.

Caused by a noise path between the door mirror and the door. Noise may be present even if no gap exists.

1. Lower the front window.
2. Carefully ease out approximately 200mm of the glass run seal.

3. Stick the foam pad (see parts required section) onto the back of the glass run seal directly over the angle in the seal (shaded in illustration). Ensure the foam extends equidistant either side of the angle, and that it does not overhang either side of the seal.

4. Carefully fit the glass run seal to the door.

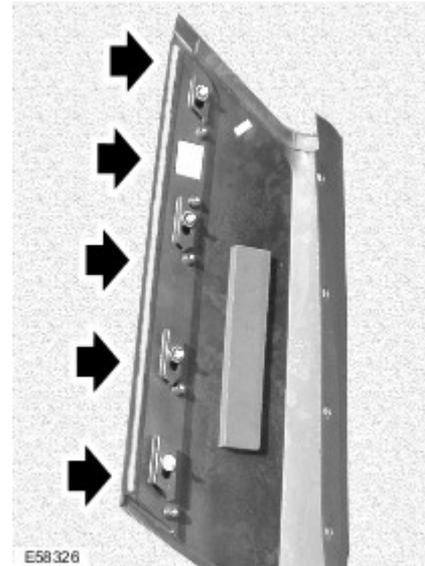
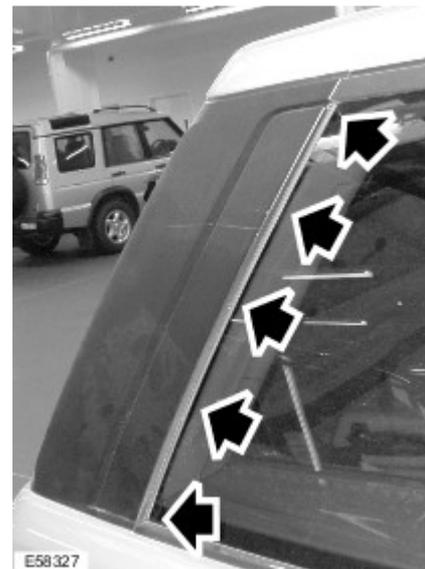
Buzzing sound from the rear of vehicle or centre of the headlining.

Caused by a gap between the E-pillar seal and the quarter-light glass.

1. Remove the E-pillar finisher. For additional information, refer to Range Rover (LM) Workshop Manual Section Exterior fittings, Finisher - 'E' post (76.43.36).
2. Clean quarter-light glass and E-pillar trim finisher.
3. Apply a 2 mm bead of sealant along the entire forward edge of the E-pillar trim finisher seal.

4. Carefully fit E-pillar finisher.
5. Remove excess sealant from E-pillar trim finisher seal and the quarter-light glass.

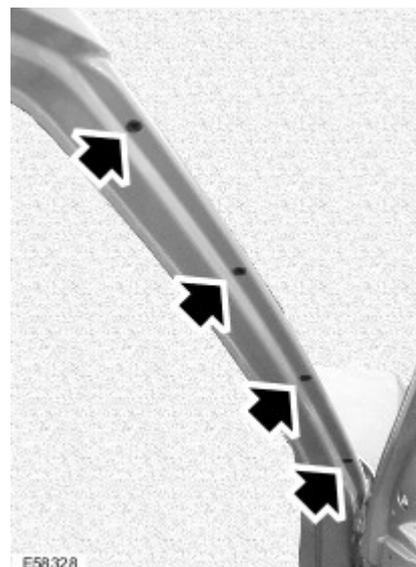
High level of wind noise from A-pillar area around 70mph (112km/h). Most likely if the side finisher has previously been removed for windshield replacement.

Caused by a gap between the side finisher and windshield or rocking/loose side finisher.

1. Remove the windshield side finisher. For additional information, refer to Range Rover (LM) Workshop Manual Section Exterior Fittings, Side finisher - windscreen (76.43.39).
2. Replace the black clips and the grommets. Ensure that new yellow clips are fitted to secure the finisher to the front of the A-pillar.

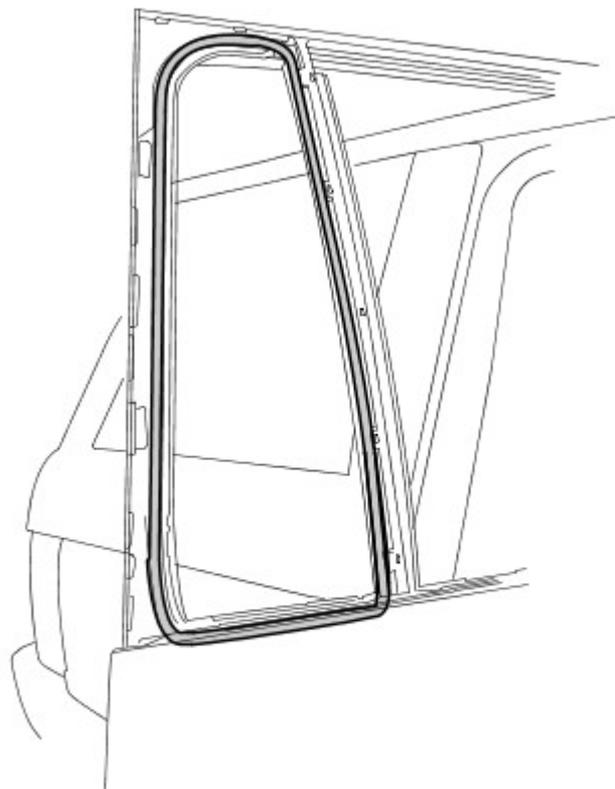
E80289

Hissing/Fluttering noise from the top rear corner of the fixed side door glass.

Caused by the rear door fixed quarter-light glass either not bonded or gaps in the bonding.

**NOTE: If fixed side door glass has been correctly bonded the Body-In-White clips should not be visible around the periphery of the fixed side door glass but should be covered by the PU. The illustration, showing the vicinity of the sill button, shows a condition that is not acceptable where there is no PU and the Body-In-White clips are visible.**

Confirm presence of PU bonding around the perimeter of the fixed side door glass (see illustration of correct PU path) and rectify accordingly.

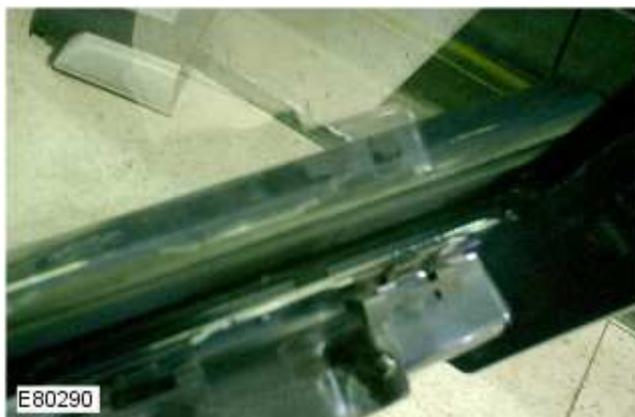
E80290

**NOTE: Rear door fixed quarter-light glass - gaps in the bonding.**

Identify any gaps in the PU bead and fill using putty, ensuring that the putty is hidden by the obscuration band.

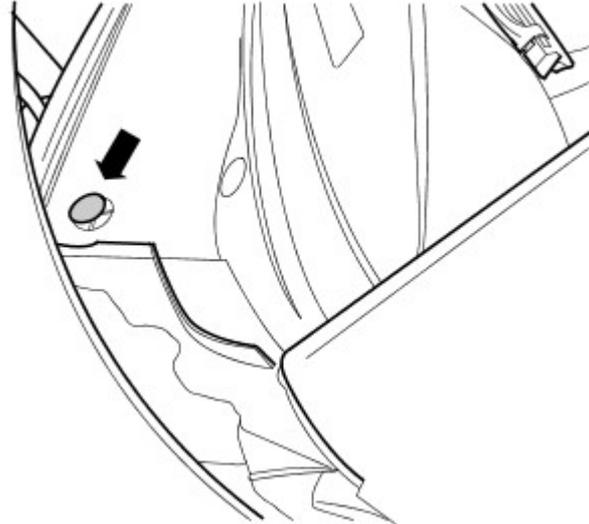
E79974

A whistle noise from the centre of the windshield at speeds in excess of 60mph (97km/h).

Caused by airflow over the passenger side plenum drain tube.

1. Tape over plenum drain tube to confirm cause of customer complaint, ensuring tape is removed after road test.
2. Insert Fir-tree clip Land Rover part Number MWC9832PMA in to the in-board front drain quadrant.

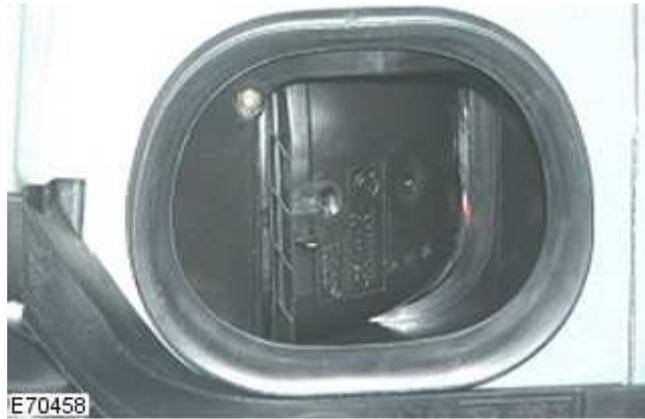
A whistle from the lower windshield area at speeds in excess of 50mph (80km/h) ONLY when the recirc is shut.

Caused by trapped footwell lamp wire in recirc snail shell.

1. Whilst reproducing the complaint operate recirc to confirm cause of complaint.
2. Remove pollen filter to access snail shell and free trapped wire.

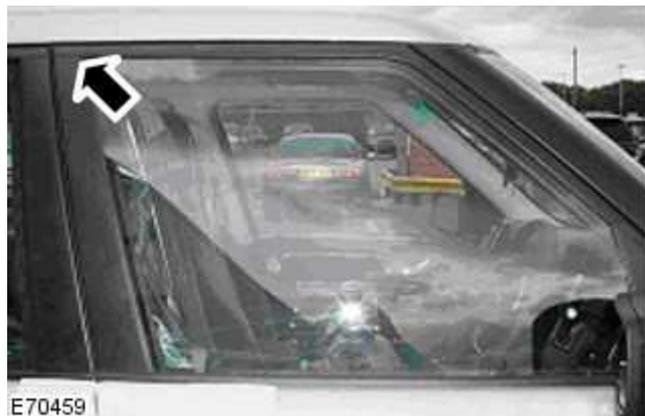
A general wind noise from top of B-Post area at speeds in excess of 30mph (48km/h)

Caused by front door glass set too far forward.

1. With the window fully closed, check whether the top corner radius of the window glass, adjacent to the B-Pillar, is visible. If visible this confirms that the window glass is set too far forward, proceed to step 3, otherwise continue to step 2.

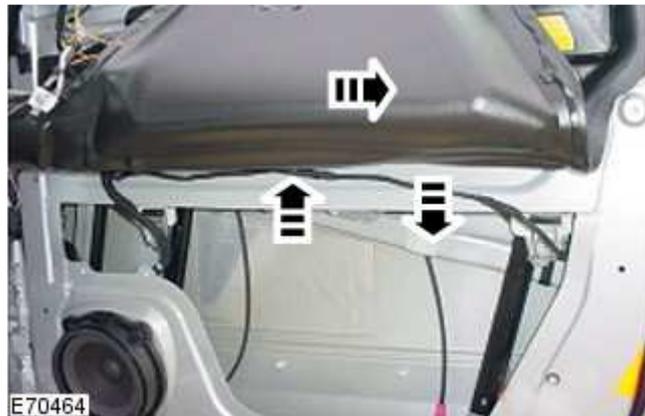
**NOTE: If attempts are made to move the glass rearwards without lifting the glass out of the clamps, the glass may return to original position due to elasticity of the rubber clamps.**

Loosen torx bolts and lift glass out of clamps, move glass rearwards, and lower glass back into clamps before securing front glass to 10 Nm (7lbf.ft).

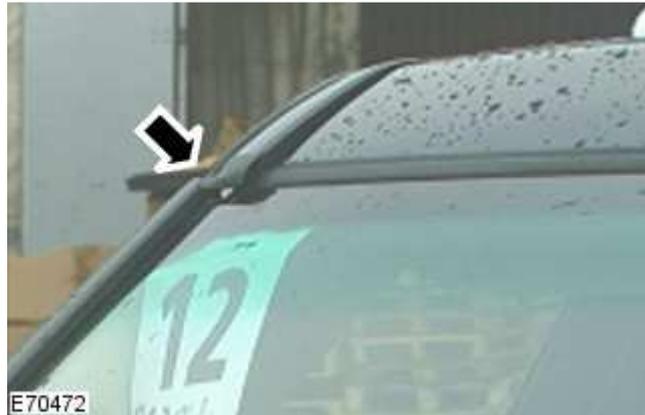
A general wind noise and whistle from top of windshield at speeds in excess of 50mph (80km/h).

Caused by leading edge of roof rail finisher lifting.

1. Unclip roof rail finisher, move back and reclip.
