TECHNICAL BULLETIN

LM501-001v4

SECTION: 501-02 (Body System - 76)

Range Rover (LM) - Wind Noise Diagnostics Aid

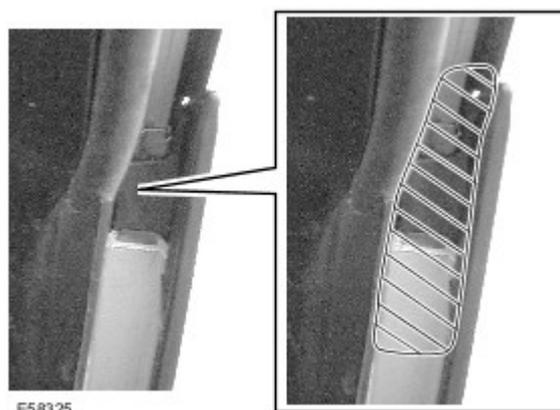
Buzzing sound from the rear of vehicle or centre of the headlining.

Caused by a gap between the E-pillar seal and the quarter-light glass.

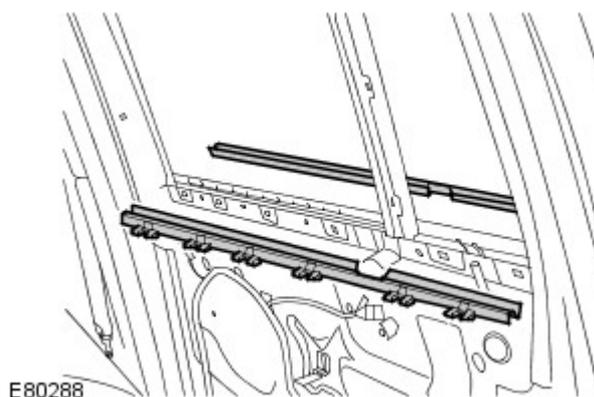
5.

Caused by the rear door fixed quarter-light glass either not bonded or gaps in the bonding.

**NOTE: If fixed side door glass has been correctly bonded the Body-In-White clips should not be visible around the periphery of the fixed side door glass but should be covered by the PU. The illustration, showing the vicinity of the sill button, shows a condition that is not acceptable where there is no PU and the Body-In-White clips are visible.**

1. Tape perimeter of fixed side door glass on the interior to confirm cause of customer complaint, ensuring tape is removed after road test.
2. Remove trim casing - rear door. For additional information, refer to Range Rover (LM) Workshop Manual Section Doors, trim casing - rear door (76.34.04).
3. Remove 'garnish' trim.
4. Remove interior waist seal.

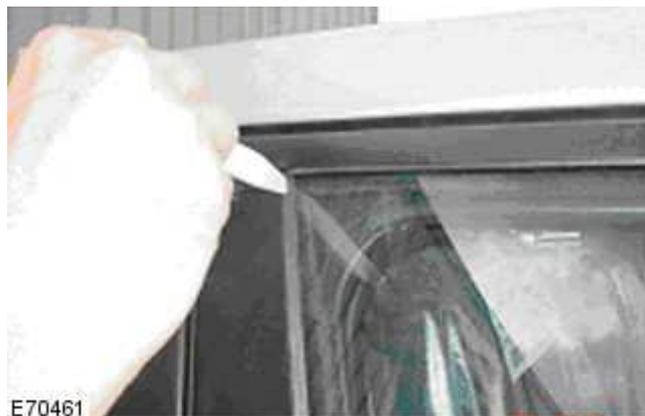
Caused by front door glass set too far forward.

1. If the glass can be felt then it is unlikely that improper window glass alignment is the cause of the complaint.

2. If the glass cannot be felt then proceed to step 3 to rectify alignment.
